Manhole Inspection Summary

Manhole # S35U__049MH

Insp Date: **2/14/08 8:42 AM**

Location Address: **1448 s.charles st**

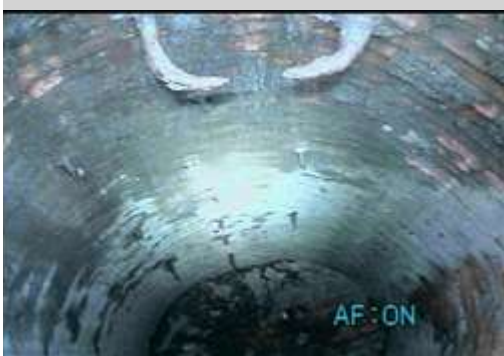
Defect 1

Count: **7** Missing: **7** ☒ **Corroded**

missing steps

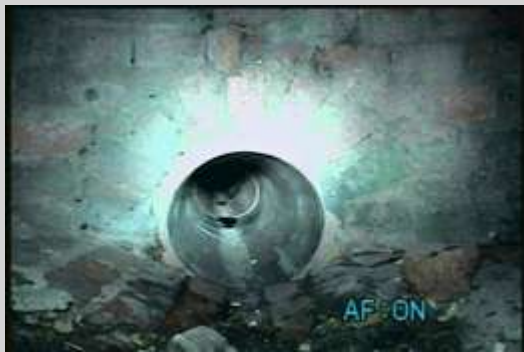
12 O'Clock Outflow

8 in. Circular Gravity Sewer
Pipe Out @ 12 O'Clock
